REPORT
SOIL INVESTIGATION
PROPOSED LIGHTY RESIDENCE
LOT 171
BERRYESSA ESTATES SUBDIVISION
NAPA COUNTY, CALIFORNIA

DH&A Job No. 5112.1

August 11, 1981

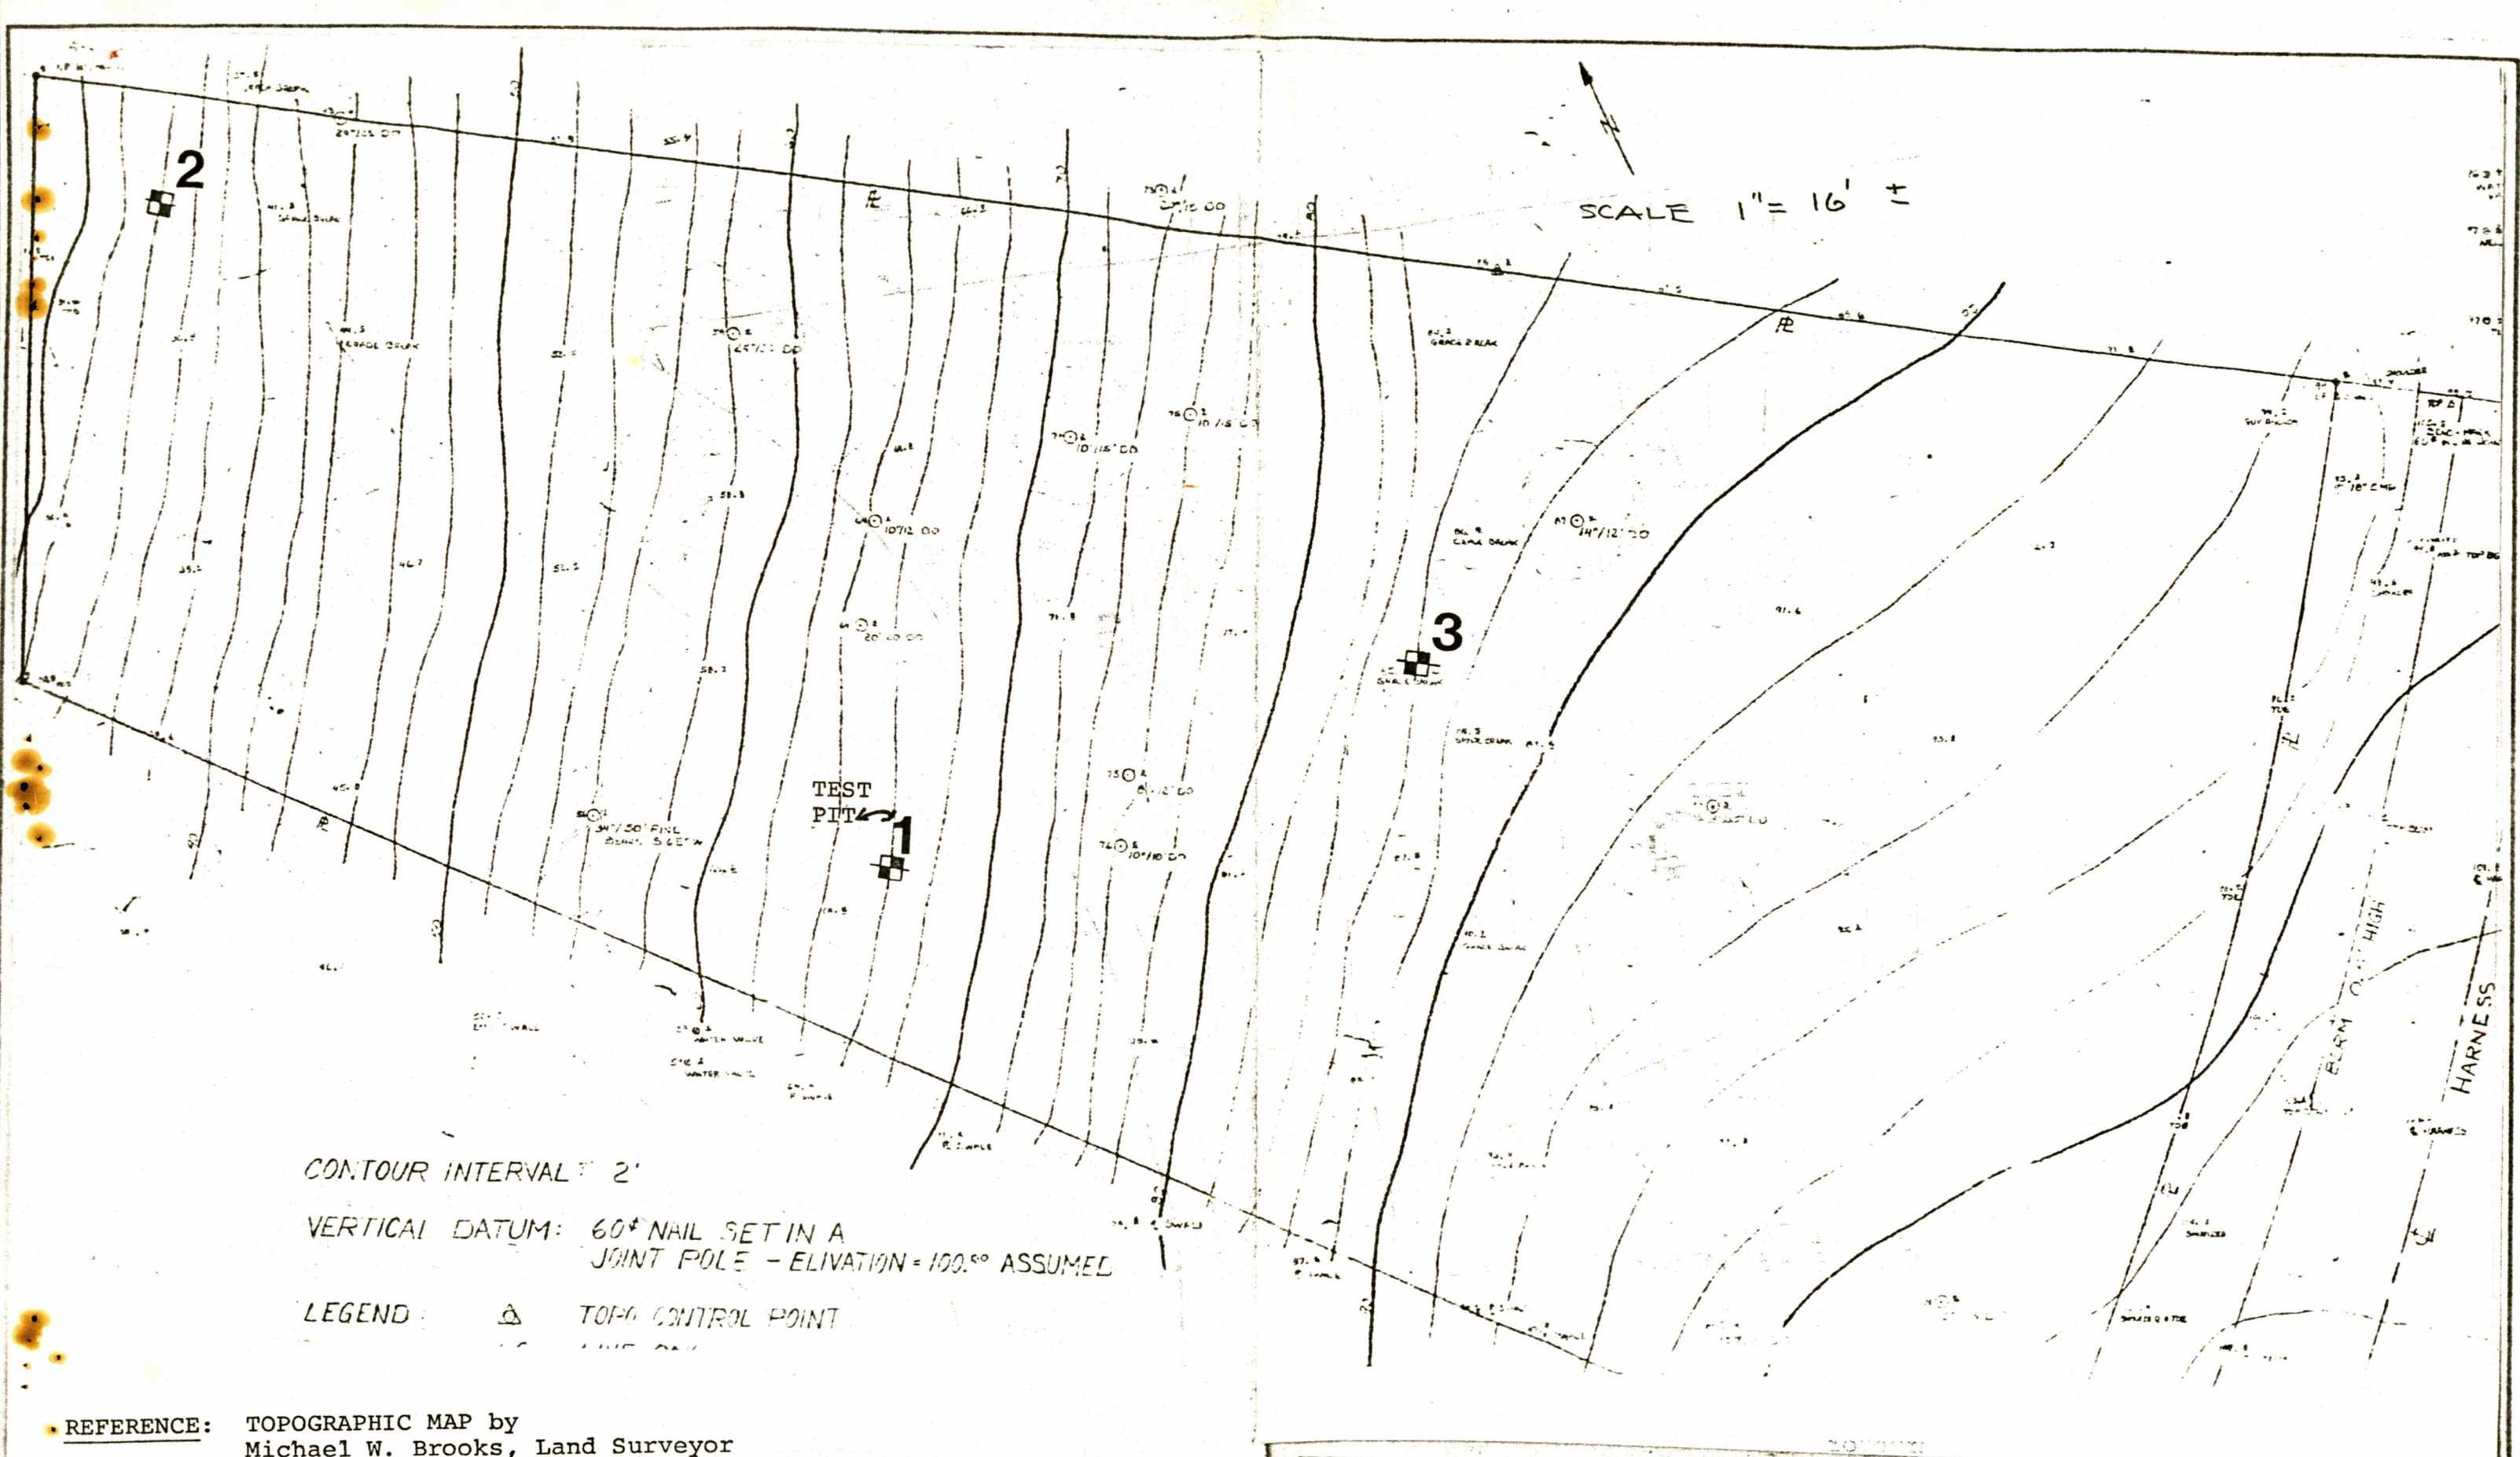
TEST PIT LOCATION SKETCH

We explored subsurface conditions at the site by excavating three test pits at the locations shown on Plate 1. The pits were excavated with backhoe equipment to depths ranging from about four to nine feet. Our engineer located the pits, observed the excavations, logged the materials encountered, and obtained a few samples for visual classification and laboratory testing.

<u>Material</u>	<u>Test Pit No. 1</u>	<u>Test Pit No. 2</u>	<u>Test Pit No. 3</u>
Topsoil and Colluvium	0' - 4'	0' - 1'	0' - 4'
Bedrock	4' - 9'	1' - 5'	---
