In this project, we do not want any rough, "freehand" drawings. ~~When final presentation~~ For the final presentation, Monday 29, we need hard line ink drawings, all in similar technique, so that we can really judge the way they work together.

Attached are some examples of streets in Amsterdam.
Please note, we are not showing you these because we
want you to copy them.

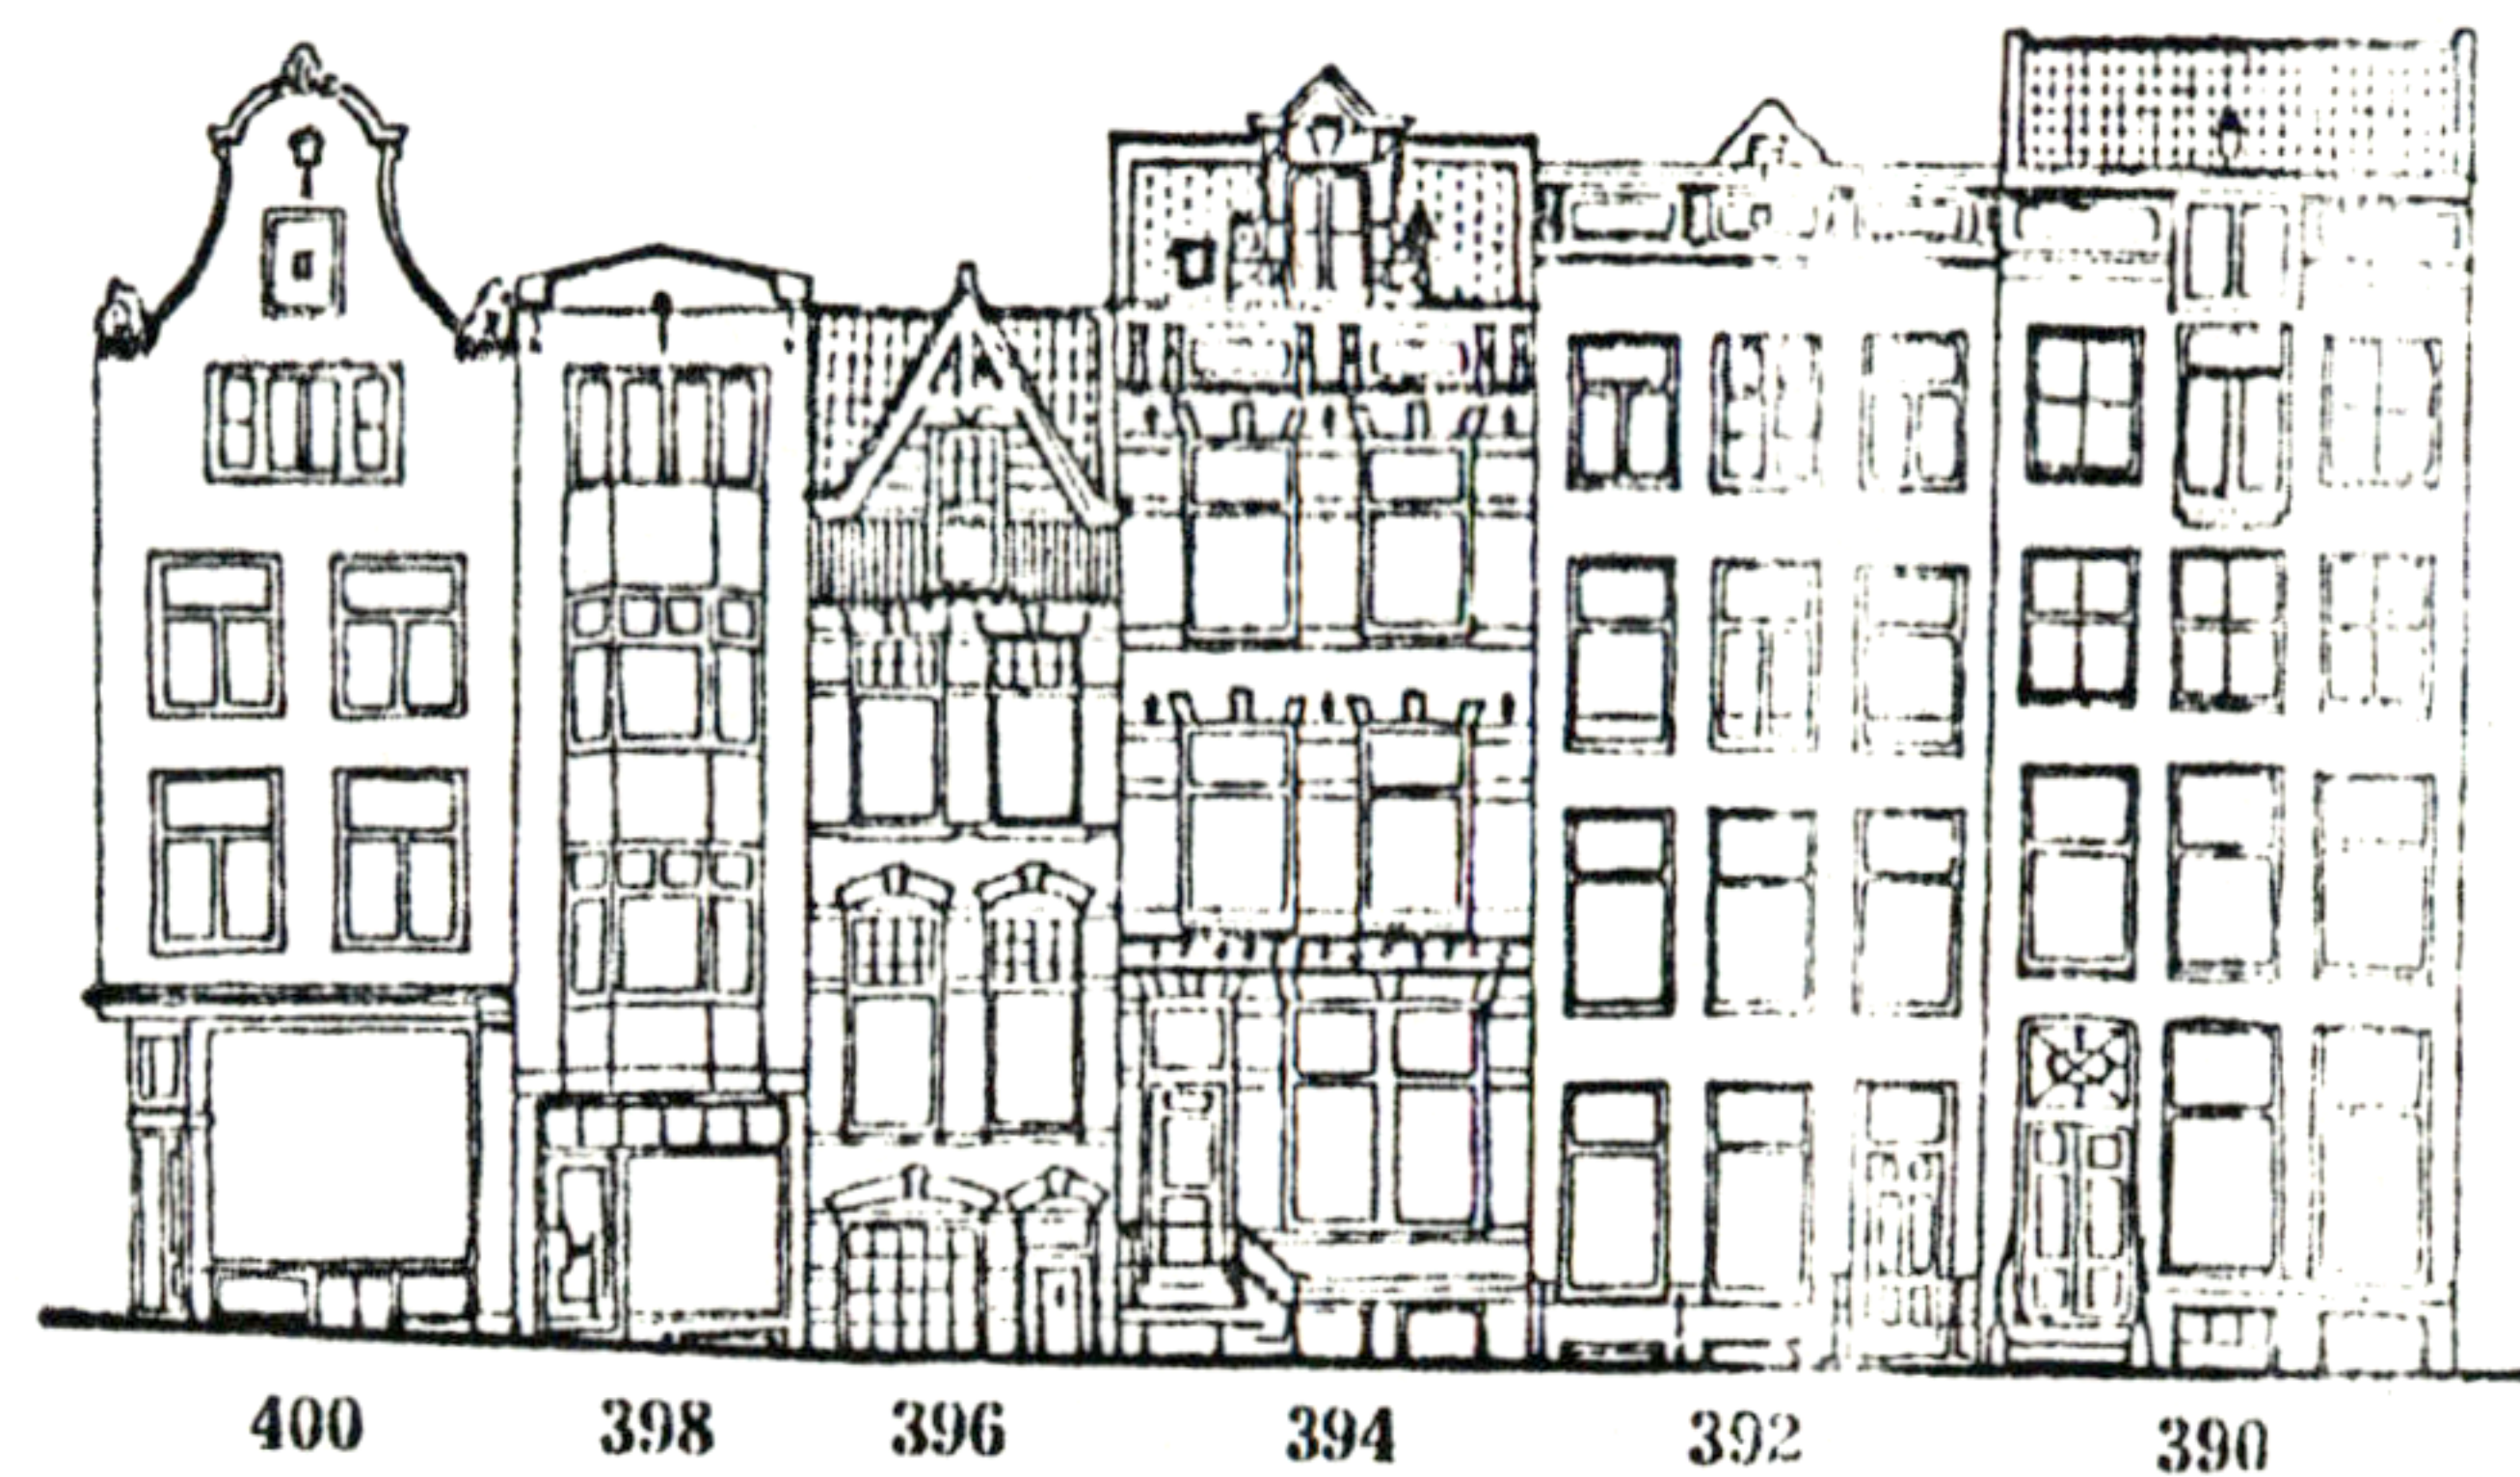
400 398 396 394 392 390

- 402 M. 1682 bell-gable with two corner vases and fronton with shell motif ornamentation; shop front early 20thC.
- 404 M. ±1770 bell-gable; white stone work above windows fitted 19thC.
- 406 M. façade drastically altered ±1880 with straight cornice and two consoles; arched windows.
- 408 façade drastically altered ±1875 with straight cornice (could be older) and two consoles; stoop gone; entrance moved to souterrain level.
- 410 ±1890 façade with brick dormer; straight cornice; flat-topped roof; ashlar street front; door at street-level.

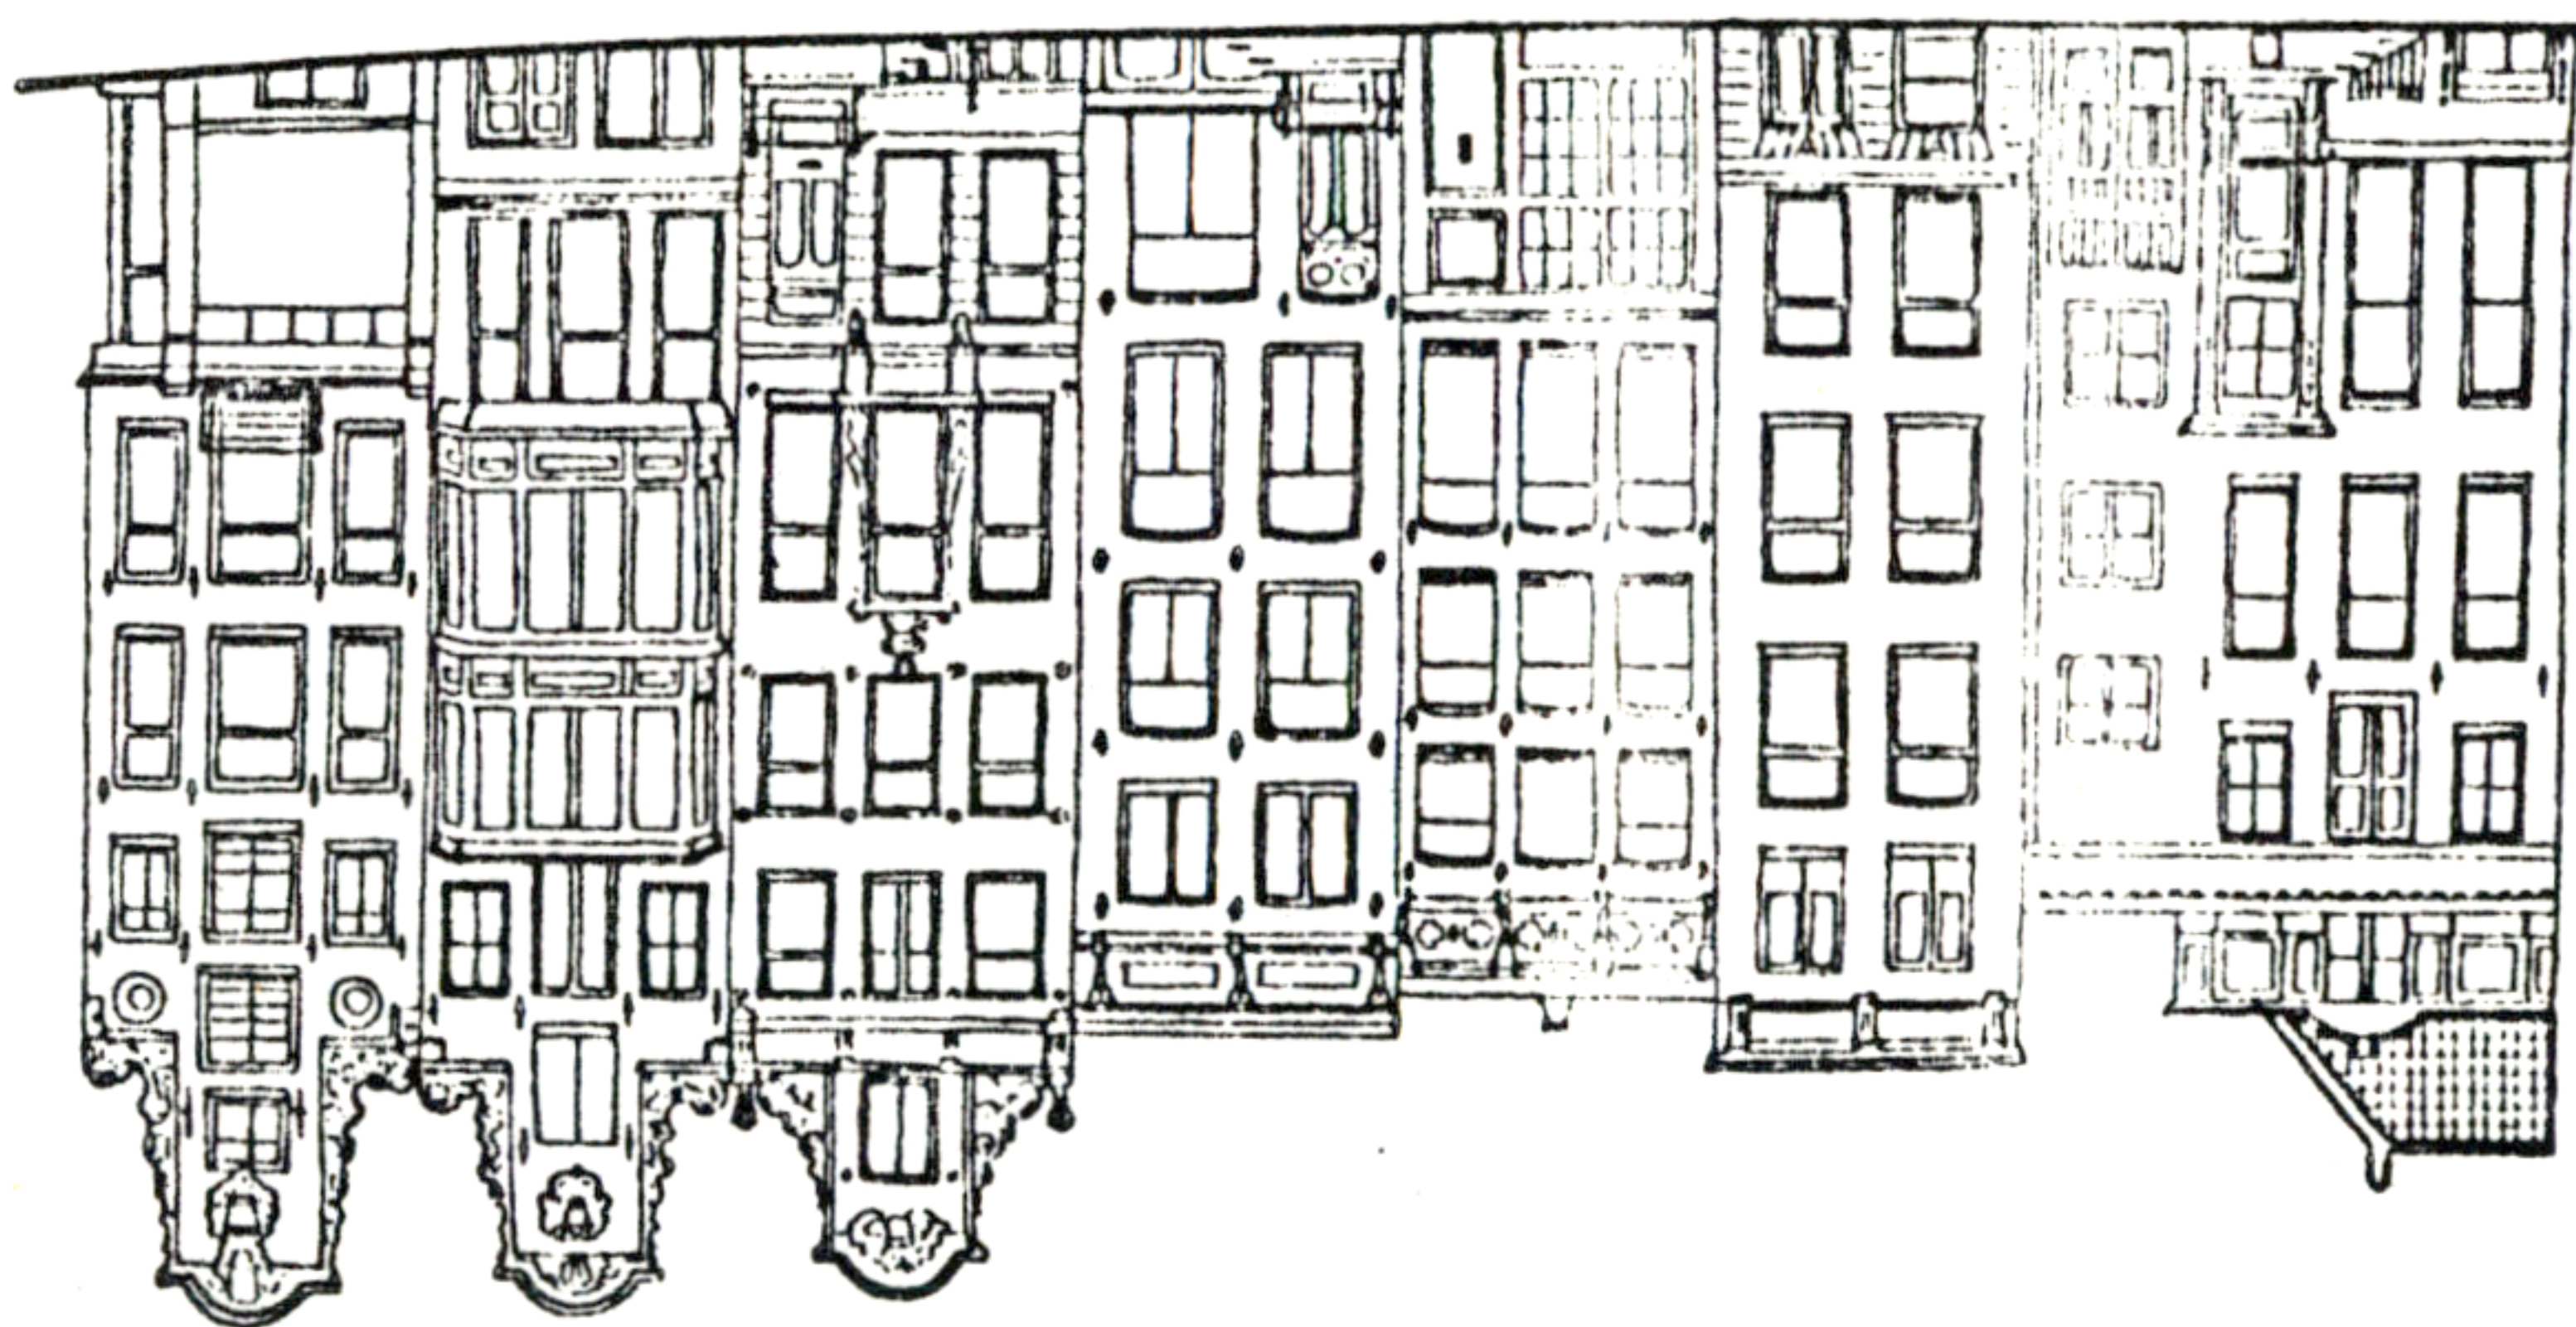
Huidenstraat

- 345-347a M. early 18thC building; floor added, straight cornice and closed attic fitted 1800; door frame from ±1800.
- 347 M. 19thC cornice façade with ashlar street front (in 19thC stoops were no longer built); entrance at souterrain level.
- 349 M. 18thC building; once a bell-gable, now straight cornice.
- 351 M. late 19thC cornice façade; ornamented anchors; stoop older.
- 353 M. ±1720 sandstone façade; unique cross between a cornice façade (see straight cornice) and neck-gable (see claw pieces).
- 355 M. ±1705 neck-gable with fronton; bay windows from 1899.
- 357 M. shop/home dating 1711; circular windows with ornamental frames; this neck-gable has always had a shop front, present one from 1907.

359-361-363 four houses stood here until November 1966 when they were demolished; the number of gaps on the canals is small and this one will be filled soon.

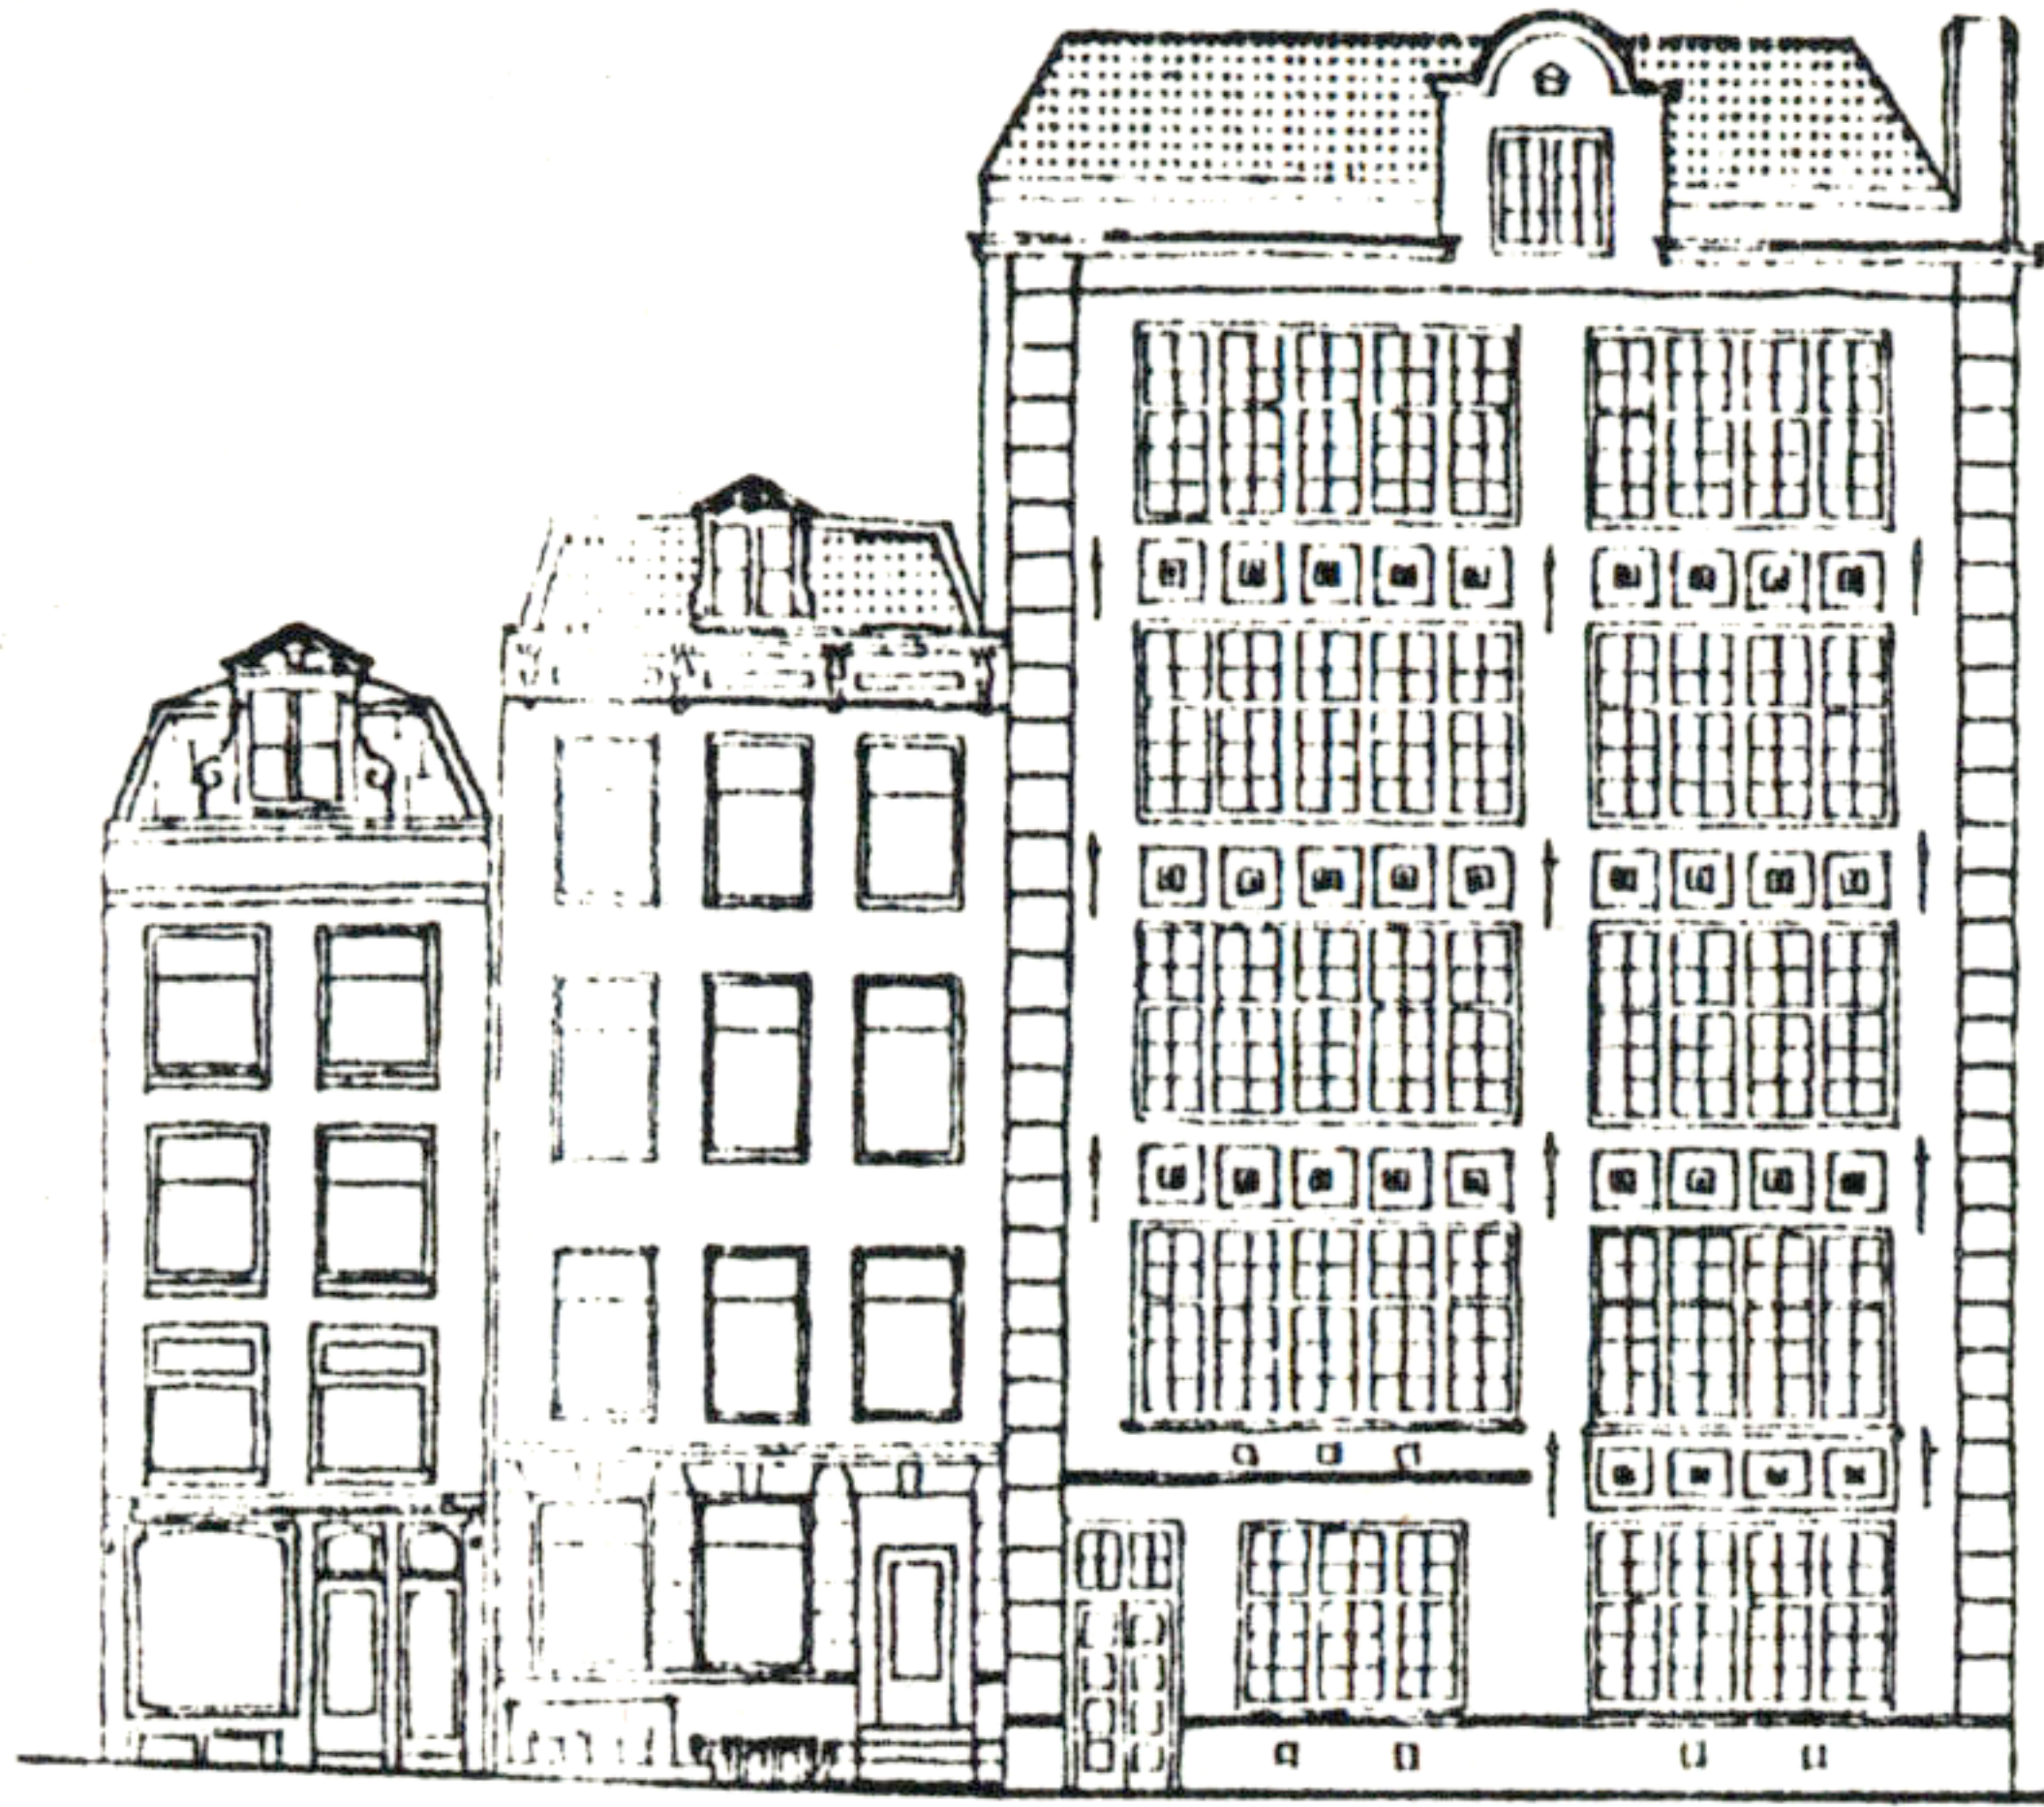
420 418 416-414

414-416 newly built in 1925; tall with brick dormer and ornamentation at the corners (so-called lisenas); accent is on windows' width (compare with no. 418); ornamentation with brick; ornamented anchors.
 418 façade with straight cornice and four consoles; dormer with hoist beam and flat-topped roof from ±1885.
 420 M. ±1860 façade with simple straight cornice and ornamented dormer.

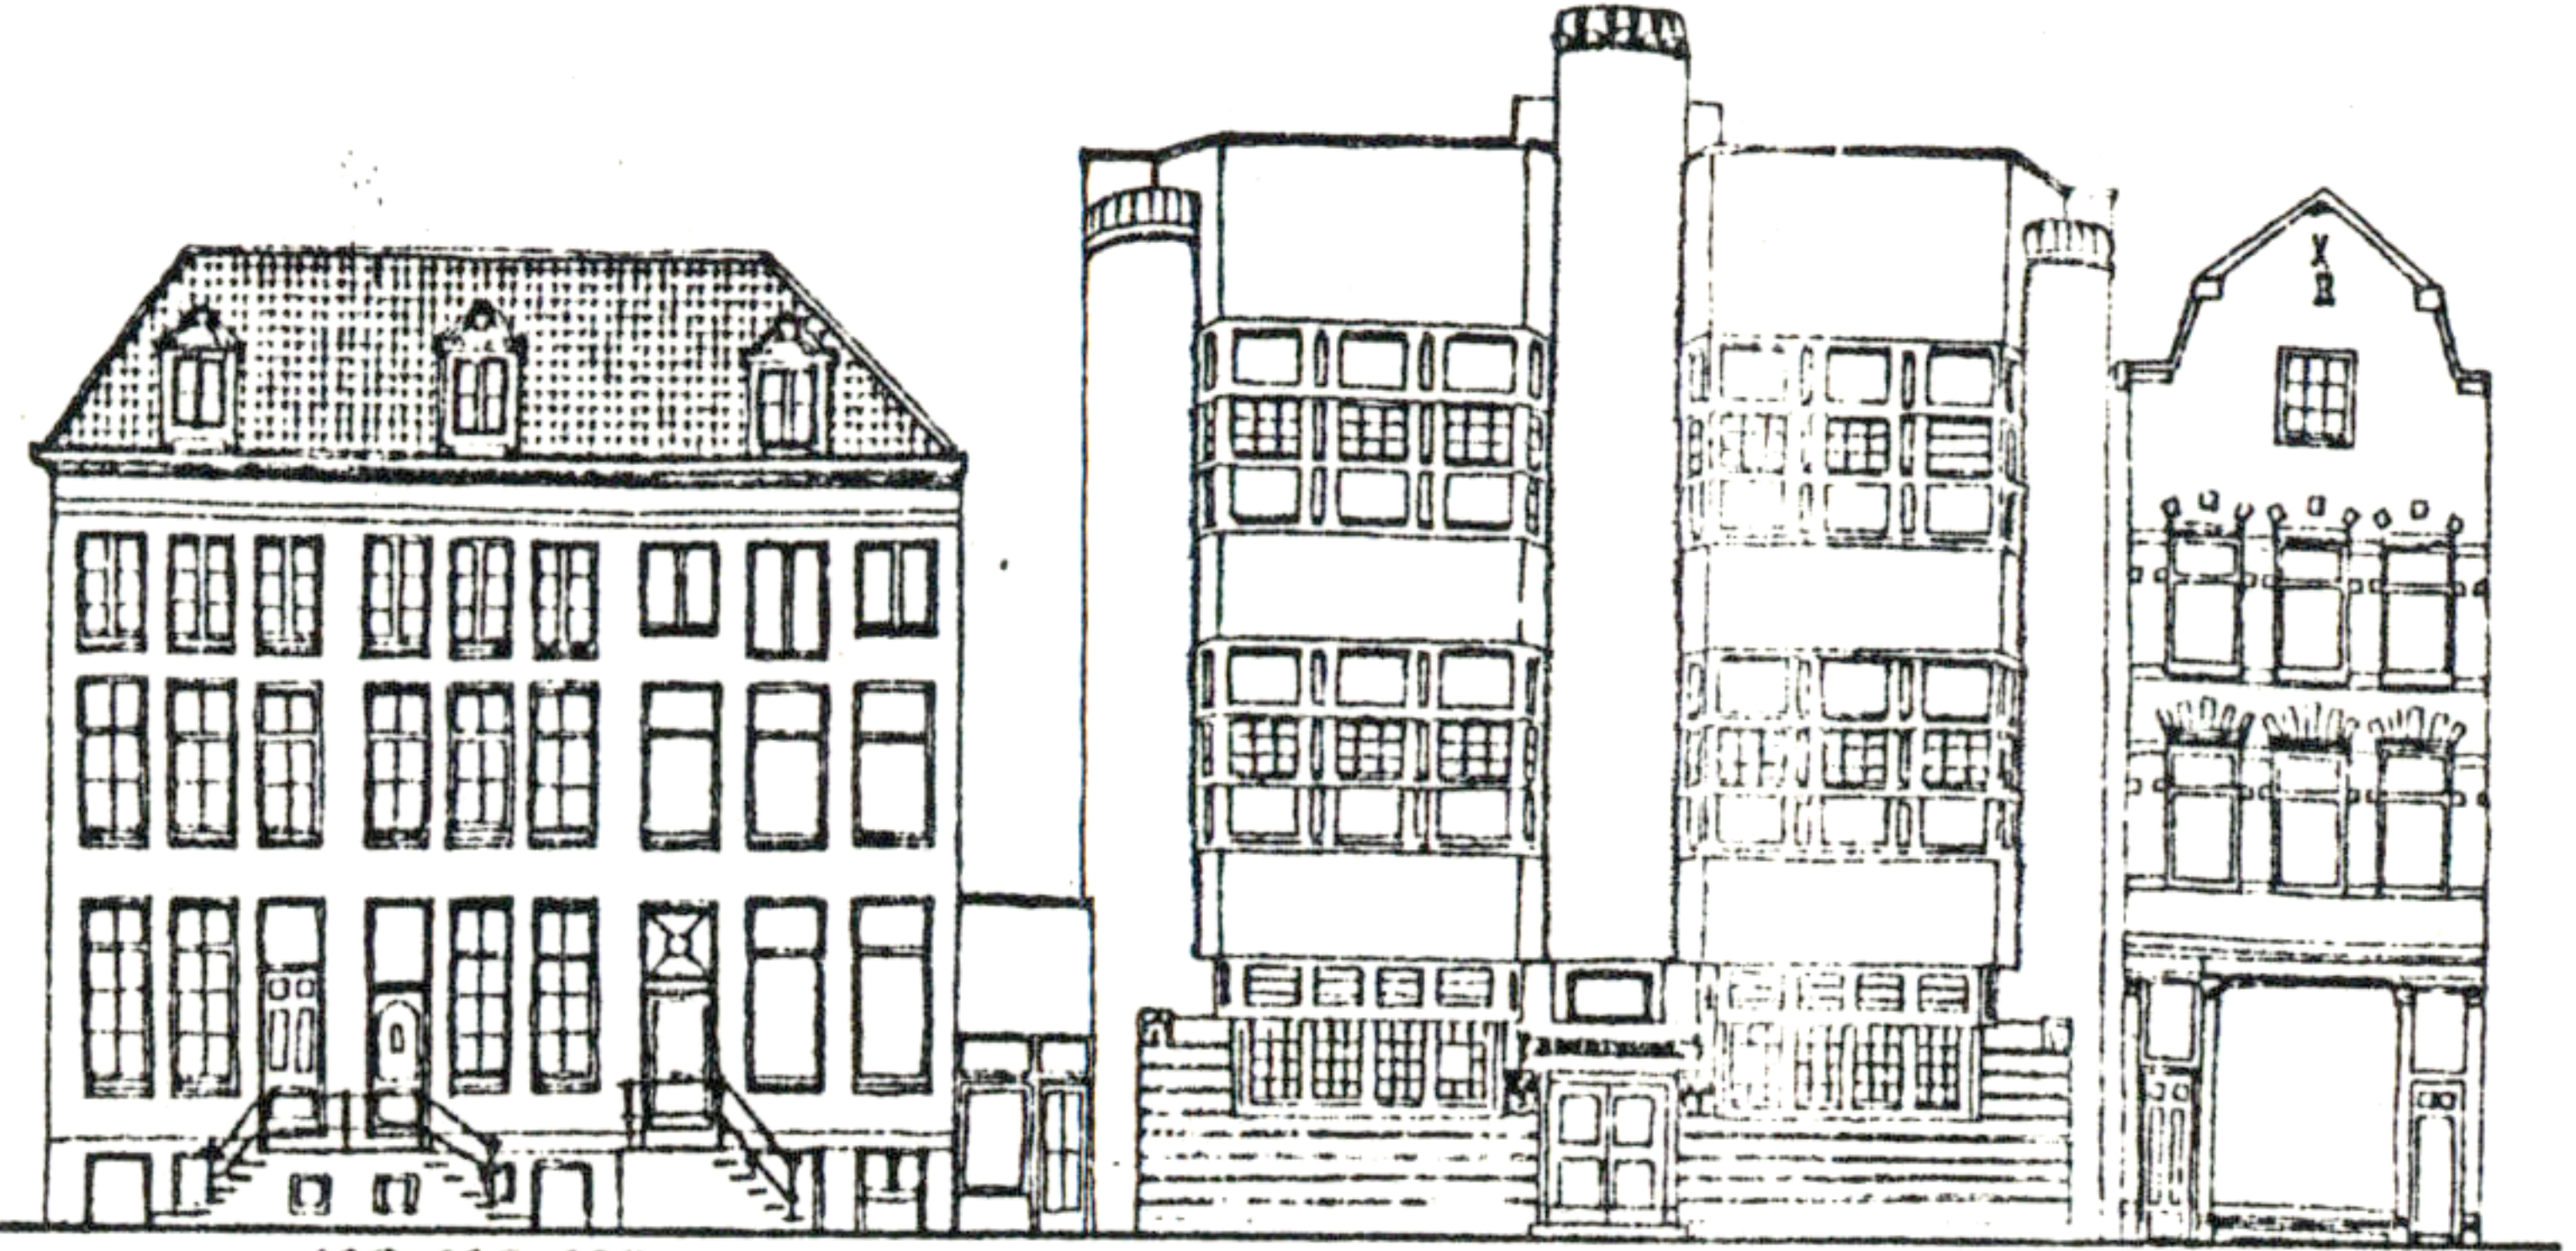
412-410-408 400 398

398 newly built in ±1800 with white stone; top later renovated now has shape of mansarde roof.
 400 newly built in 1925 with Amsterdam School features; outward bending relief, ornamentation with brick; two sculptured heads near doors; much use was made of sculpture in this period.
 408-410-412 M. three almost identical 18thC houses under one large roof; the straight cornices date from the early 19thC; windows grow smaller towards top like in most old Amsterdam houses.
